Volume 5  
August 2005

## SPRINKLER SYSTEM FAILURE

IT CAN HAPPEN ANYWHERE, ANYTIME

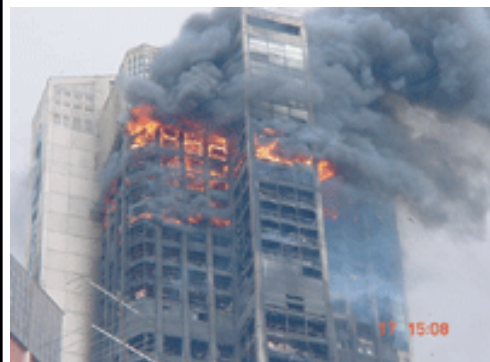
*The fire reaches the 47th floor of the Parque Central in Caracas, Venezuela*

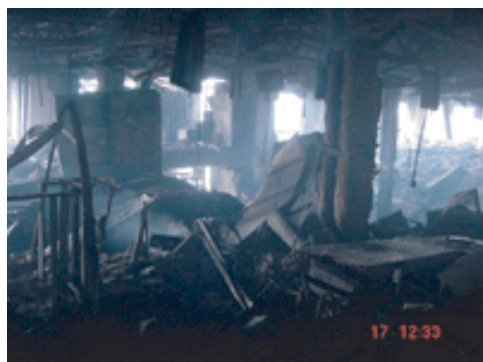
*This image was taken by retreating fire personnel as they left the partially collapsed 35th floor*
